REPORT#: 22CA002

Warehouse Worker Dies When Material Falling Off of Pallet Strikes Him — California

Fatality Assessment and Control Evaluation (FACE) Program

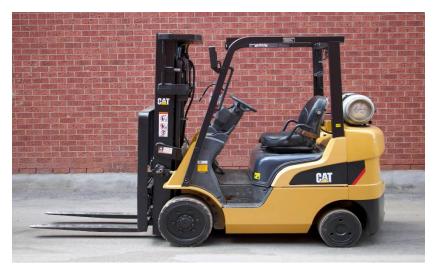
The primary piece of equipment involved with this incident was a CAT® model 2C6000 forklift (Exhibit 2). The forklift is a relatively small indoor/outdoor, liquid propane fueled forklift that has a lifting capacity of about 6000 pounds and weighs about 9,440 pounds. Safety features include overhead guards (to protect the driver from falling objects), side/rearview mirrors, a backup alarm, strobe lights and a loud, audible horn.

Exhibit 2. A CAT® model 2C6000 forklift (similar model, not actual used in the incident).

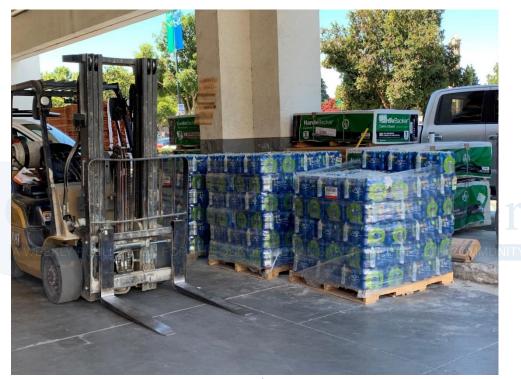
backwards slightly and causing it to tilt at a slight angle. The cased water on the top pallet further shifted against the shrink wrap, which gave way and dumped the entire pallet of cased water on the victim.

Exhibit 3. Incident location with CAT® forklift (similar model, not actual used in incident) and pallets of product identical to those that struck the victim. Photo by CA/FACE program.

In this incident, the forklift's forks were placed under the top pallet which created a tilted, unstable load. If a method had been used to manually break down the unbalanced/unstable pallet, this death could have been prevented.

Recommendation #5: Employers with retail warehouse operations should include a method for correcting (manually breaking down and restacking merchandise on) unstable or unbalanced pallets in their Standard Operating Procedures (SOP).
