Hazards of Inadequately Securing Hydraulic Excavator Buckets When Using Quick Coupling Devices

Safety and Health Information Bulletin

SHIB 07-22-2005

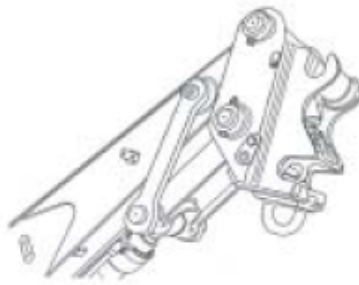
Figure 1

Most quick couplers are after-market devices that have been used on hydraulic excavators for several years and have steadily increased in popularity. They enable contractors to quickly make attachment changes on hydraulic excavators. Most quick couplers have a lifting eye to use for lifting material. (Figure 1).

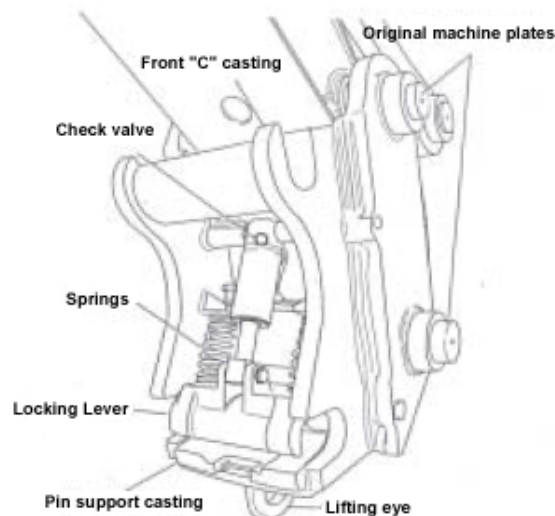
Figure 3

Many contractors like to use a large bucket to do the bulk of the digging and to then change to a smaller bucket for fine tuning and working in tight areas. The quick couplers also allow the operator to change from a bucket attachment to various other attachments. In most cases, the unexpected releases of buckets and other attachments are likely caused by the failure to properly engage and lock the quick couplers. (Figures 3 & 4).

- Inspecting all quick couplers to determine if they are subject to unexpected release hazards. Determine whether a manually installed locking pin and installation procedures (or other retrofitting methods) have been provided by the manufacturer.

- If appropriate, obtaining and installing retrofits recommended by the manufacturer, including positive locking pins and other devices that need to be manually installed.

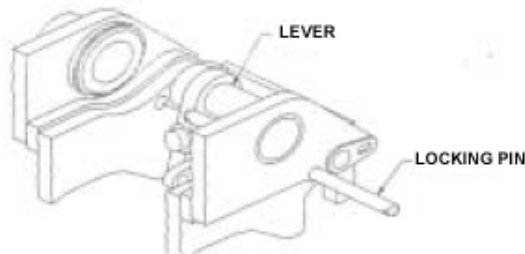
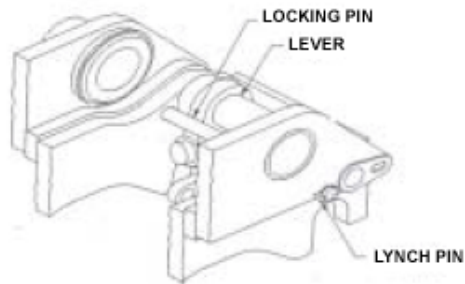
Figure 5

Quick couplers are made by various manufacturers. Manufacturers of quick couplers have recognized the hazard of the bucket or other attachments being unexpectedly released from the quick couplers and, in many cases, have provided users with a retrofit locking pin (Figures 5 & 6) which is manually inserted behind the front lever (stick pin) or rear lever (link pin) of the couplers to prevent unintended releases.
